Waste Site Reclassification Form

**REPORT FOR THE 600-235, LEAD-SHEATHED TELECOMMUNICATIONS
CABLE SAMPLING**

Attachment to Waste Site Reclassification Form 2001-091

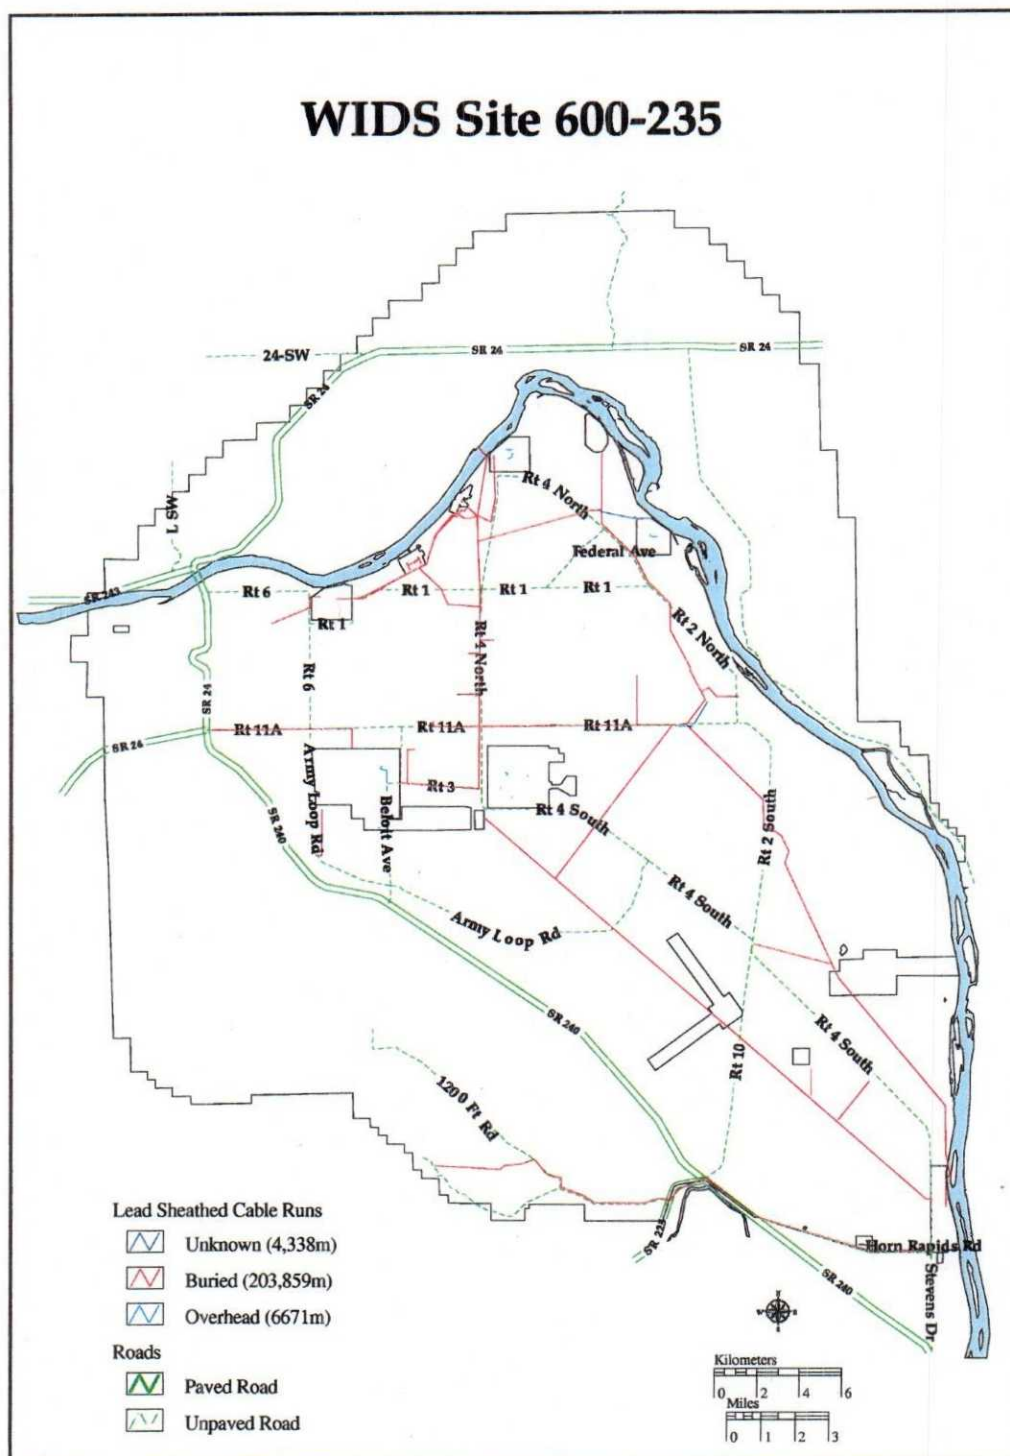
Figure 1. Map of Lead-Sheathed Telecommunications Cable.

Lead-sheathed telecommunications cable continued to be installed at the Hanford Site until the mid-1950s when polyethylene-sheathed, plastic-insulated cables were introduced. When necessary, lead-sheathed cables were removed or replaced with polyethylene cables; however, it is unknown if this applies to aerial or underground cables. Lead-sheathed cables were generally buried to a depth of 61 to 91 cm (24 to 36 in.). Documentation indicates that 2,696.4 m (8,846 ft) of aerial cable was removed from the 100-B/C and 100-D Areas, and 2,035 m (6,673 ft) was removed from the 100-H and 100-F Areas. Information on other cable removal actions is not available. Currently, some of the cable is being used in the 100-K and 100-N Areas. Prior to 1993, General Electric Telephone Northwest abandoned about 483 km (300 mi) of telephone cable on the Hanford Site; about 50% of this total was buried. Figure 1 provides a map showing the location of buried and overhead lead-sheathed cable runs, as provided by Lockheed Martin Hanford, Inc. An estimated 7.4 km (4 mi) of the lines shown are aerial, about 4.8 m (3 mi) are unknown, and the rest (204.4 km [127 mi]) are buried.

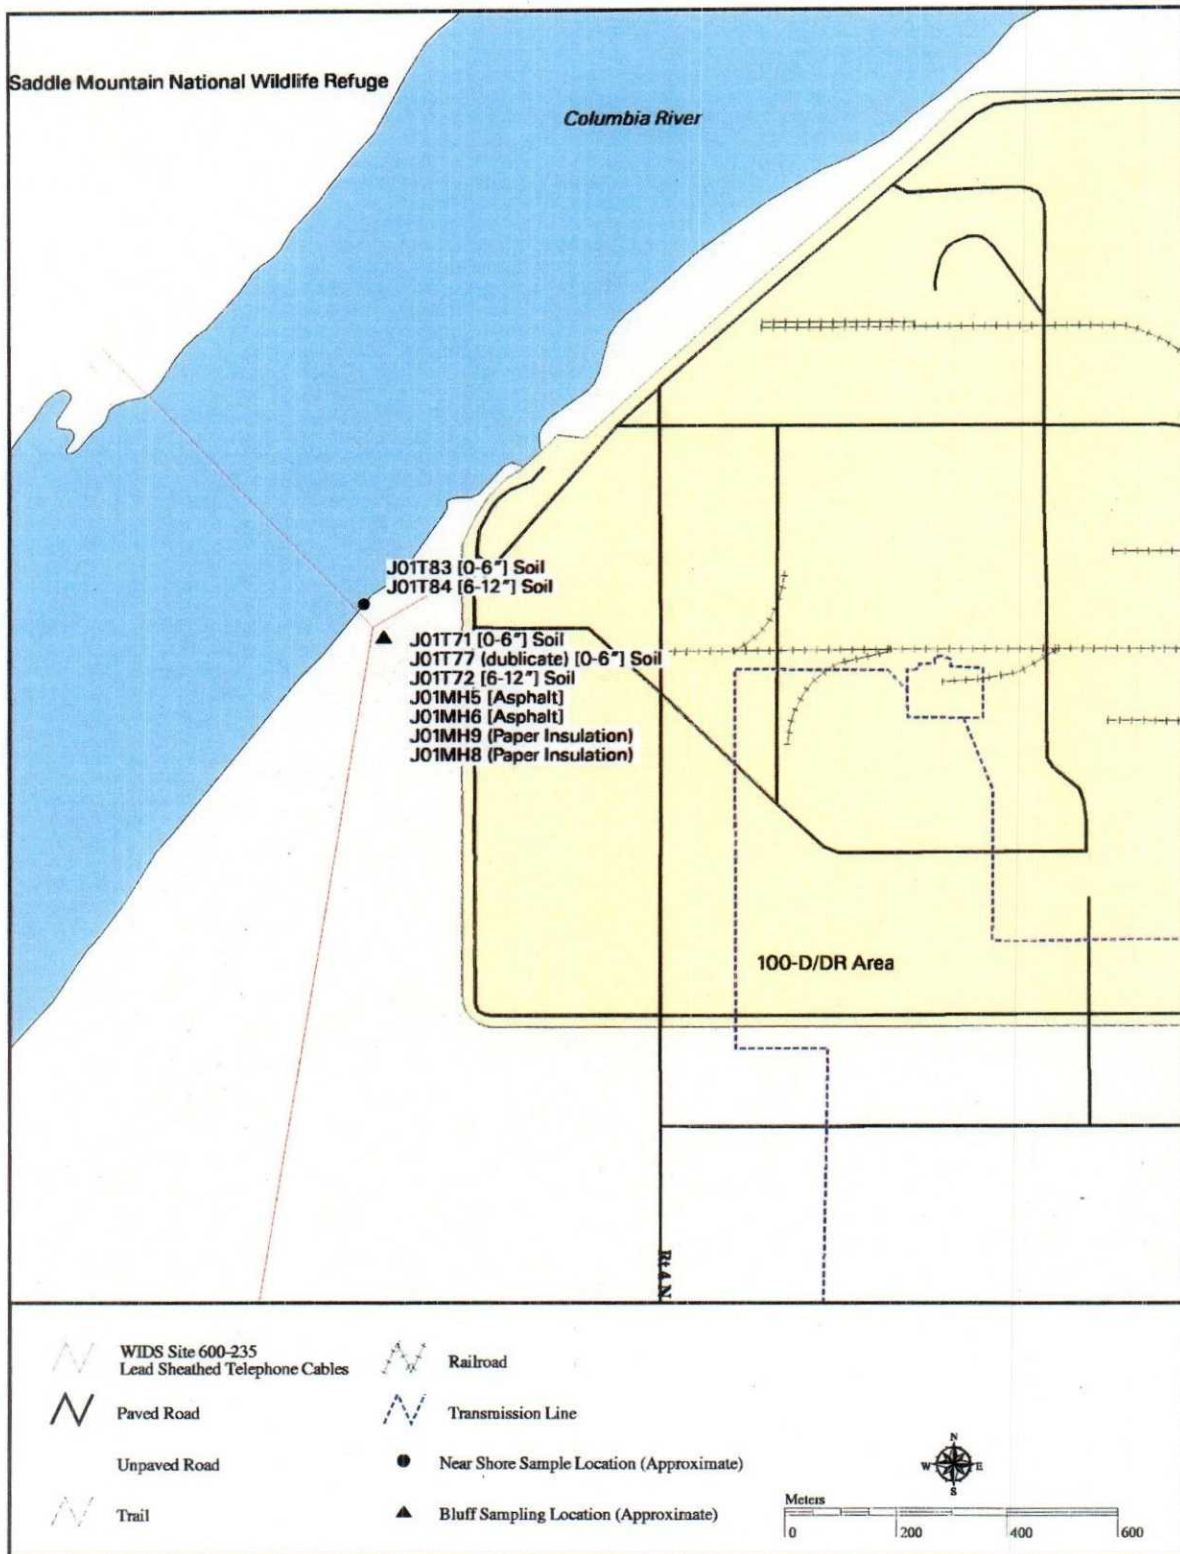
Figure 2. Sample Location Near the 100-D/DR Area.

1. Buried cable on the bluff northwest of the 100-D Area at the location where the cable crosses the Columbia River (Figure 2).
2. Exposed cable northwest of the 100-D Area in the riparian zone where the cable crosses under the Columbia River (Figure 2).
3. Buried cable located southwest of the 100-N Area at the west end of the 100-N-19 construction debris disposal dump site (Figure 3).
4. Buried cable located approximately 3.2 km (2 mi) southeast of the 200 East Area on the north side of Route 4 (Figure 4).
5. Buried cable located in the floodplain on the north side of the Columbia River (Figure 5).
6. Buried cable on the bluff above the floodplain on the north side of the Columbia River (Figure 5).

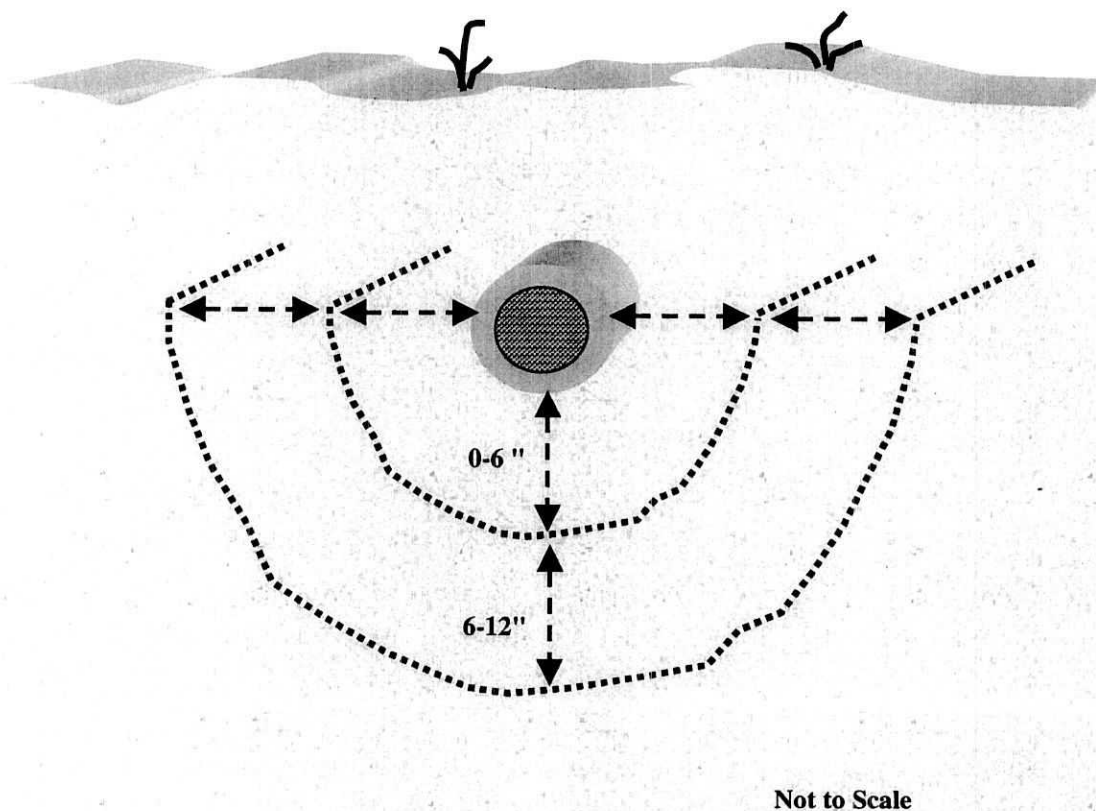
Figure 6. Soil Sampling Cross-Section.

To assess the potential leaching of the lead-sheathed cable into the adjacent soil, samples were collected in the vicinity of the cable at each of the 6 locations. Two soil horizons were sampled at each location – one immediately beneath/adjacent to the cable to a depth of 15.2 cm (6 in.), and a second from a depth of 15.2 to 30.5 cm (6 to 12 in.) beneath the cable. Figure 6 is a cross-section schematic of the soil sampling strategy. For each cross-section soil horizon, a length of cable was exposed so that sufficient soil could be collected to provide for the required sample analyses. Each soil sample horizon was combined along the length of the cable into one sample for analysis of arsenic, barium, cadmium, chromium, lead, mercury, selenium, silver, PAHs, and PCBs, for a total of two soil samples at each location (i.e., one sample from each horizon).

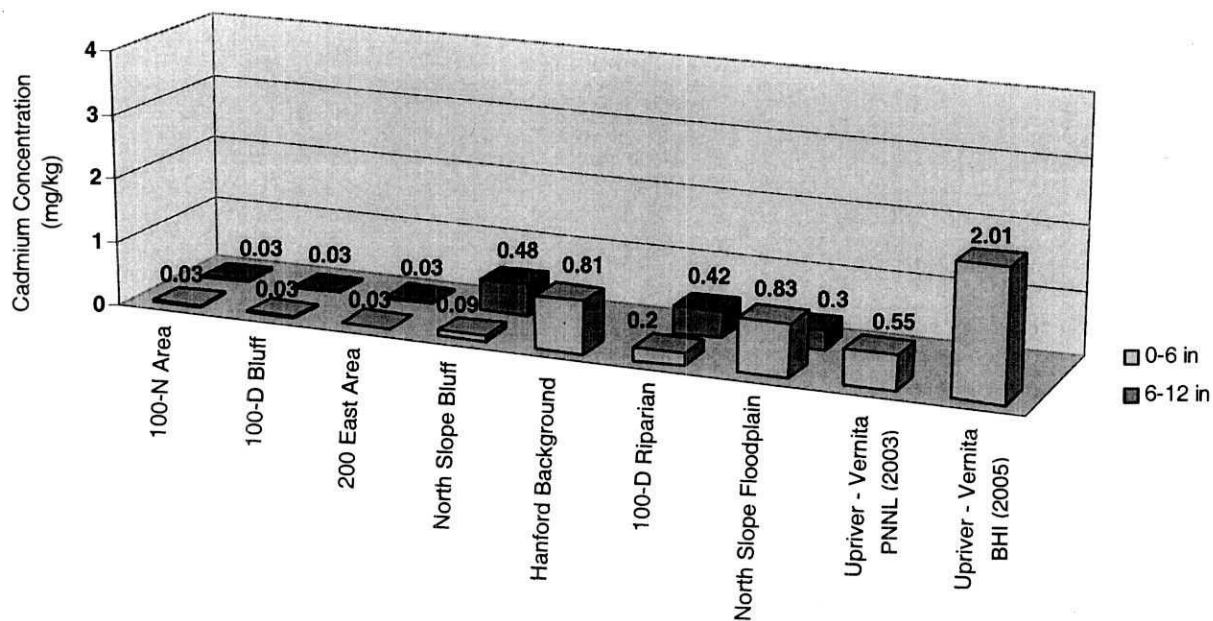
Figure 8. Cadmium Concentrations in Soil.

Metals. Mercury, selenium, and silver were not detected above the laboratory PQLs in any of the soil samples. Arsenic was detected at concentrations ranging from 1.7 mg/kg to 6.9 mg/kg, below the WAC 173-340-740(2) (Ecology 1996) Method A cleanup level of 20 mg/kg. Barium was detected at concentrations ranging from 56.6 mg/kg to 91.6 mg/kg, below the Hanford Site background concentration of 132 mg/kg (DOE-RL 1998a). Cadmium was detected in five soil samples ranging from 0.2 mg/kg to 0.83 mg/kg. Only one sample slightly exceeded the statewide background concentration of 0.81 mg/kg. This sample was collected at the North Slope floodplain location in the 0- to 15.2-cm (0- to 6-in.) sample horizon. Chromium was detected in concentrations ranging from 4.0 mg/kg to 46.6 mg/kg. Two samples exceeded the Hanford Site background concentration of 18.5 mg/kg. These samples were collected at the 0- to 15.2-cm (0- to 6-in.) and 15.2- to 20.3-cm (6- to 8-in.) horizons at the North Slope floodplain location. Lead was detected in concentrations ranging from 2.4 mg/kg to 34.2 mg/kg. Three samples exceeded the Hanford Site background concentration of 10.2 mg/kg. Two of the samples were from the North Slope floodplain location, and one was collected from the riparian zone at the 100-D sampling location.

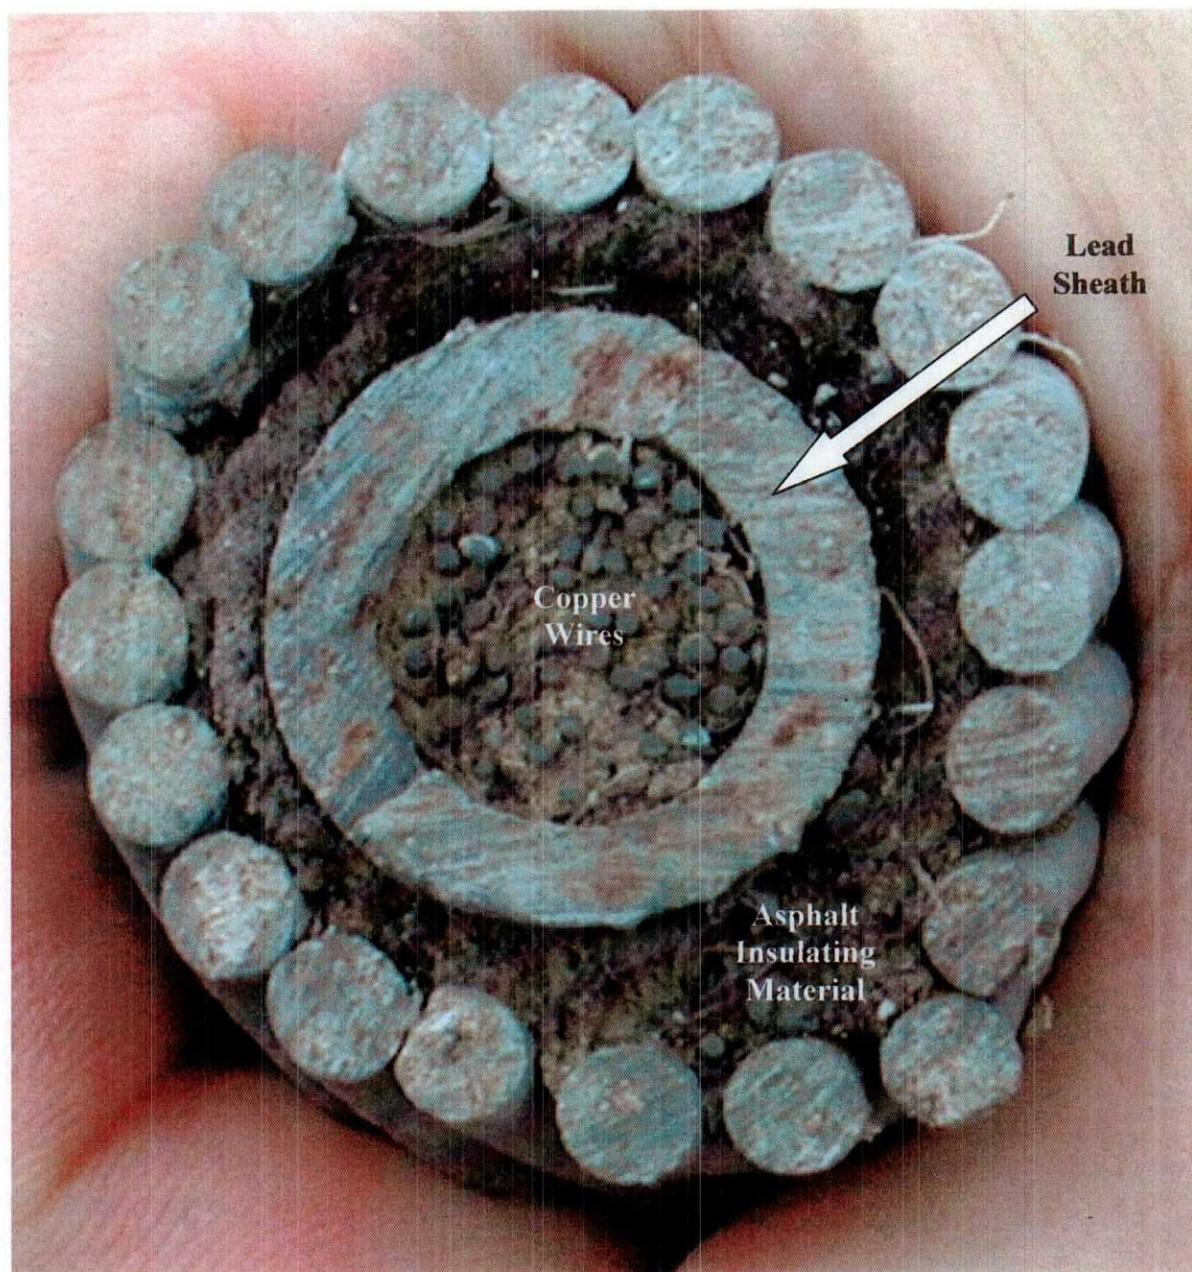
Figure B-1. Telecommunications Cable.

The cable consists of a varying number of inner copper wire strands, individually wrapped in an extremely thin paper, with a very thin twine used as a void filler. The group of copper wires is then wrapped in the lead sheathing. Figure B-1 shows a cut end of the telecommunications cable at the south side of the Columbia River, near the location where the cable crosses under the river. An insulating material consisting of a rope/twine wrap covers the lead and is coated with an asphalt material. Surrounding the outside of the insulation are metal wires (appearing to be galvanized steel) that are spirally wrapped around the cable to protect it. This outer metal wire wrapping is found only on the telecommunications cable that crosses under the river. It was likely used to protect the cable and assist in stretching it across the river. The photograph in Figure B-2 was taken on the north shore of the Columbia River and shows the lead sheath, the twine/asphalt-coated insulation, and the outer metal wire wrap. Some of the scrap cable on the surface of the Columbia River north shore was observed to have an additional twine wrapping on the outside of the metal wire wrap (see Figure B-3).

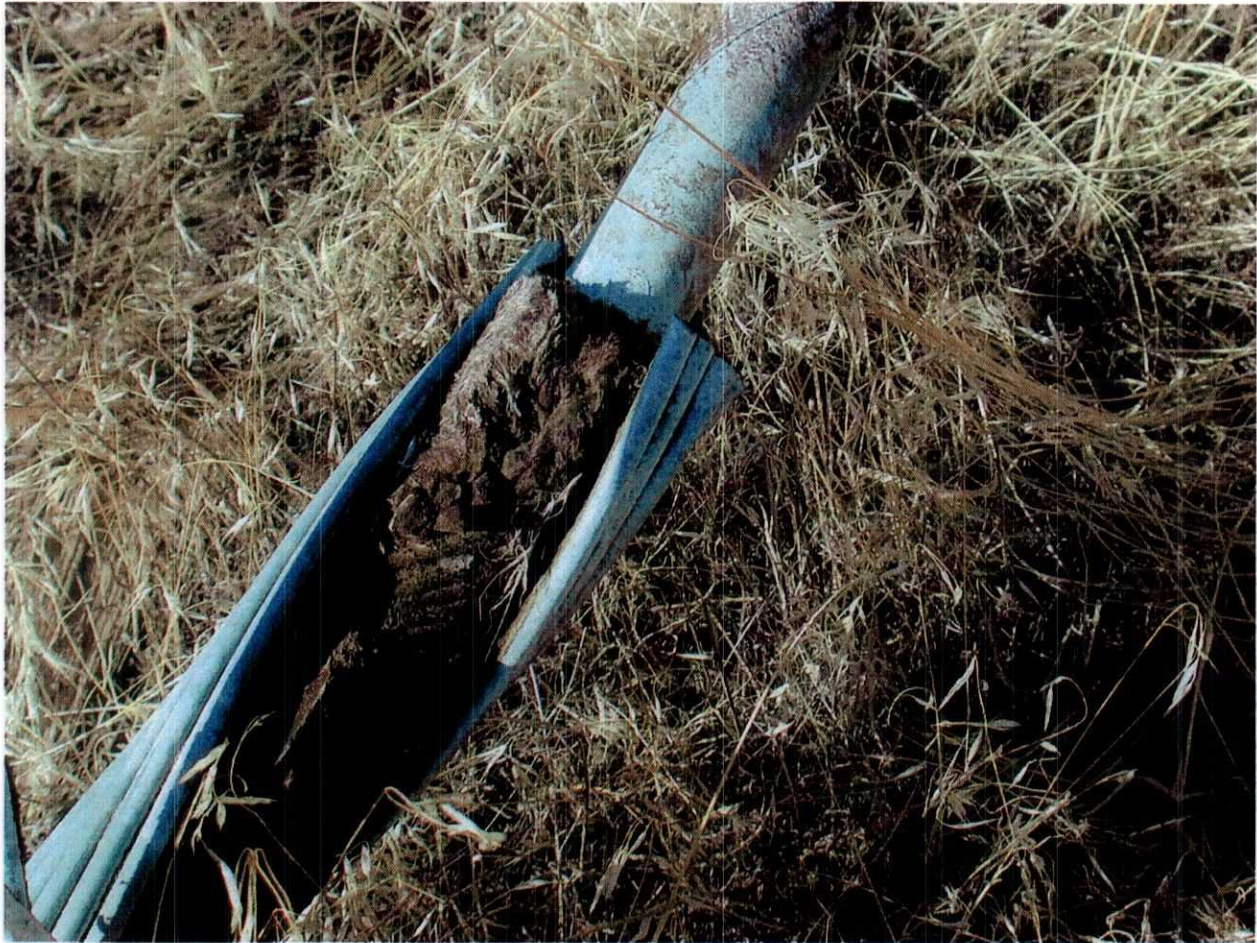
Figure B-2. Telecommunications Cable with Lead Sheath, Twine/Asphalt-Coated Insulation, and Outer Metal Wire Wrap.

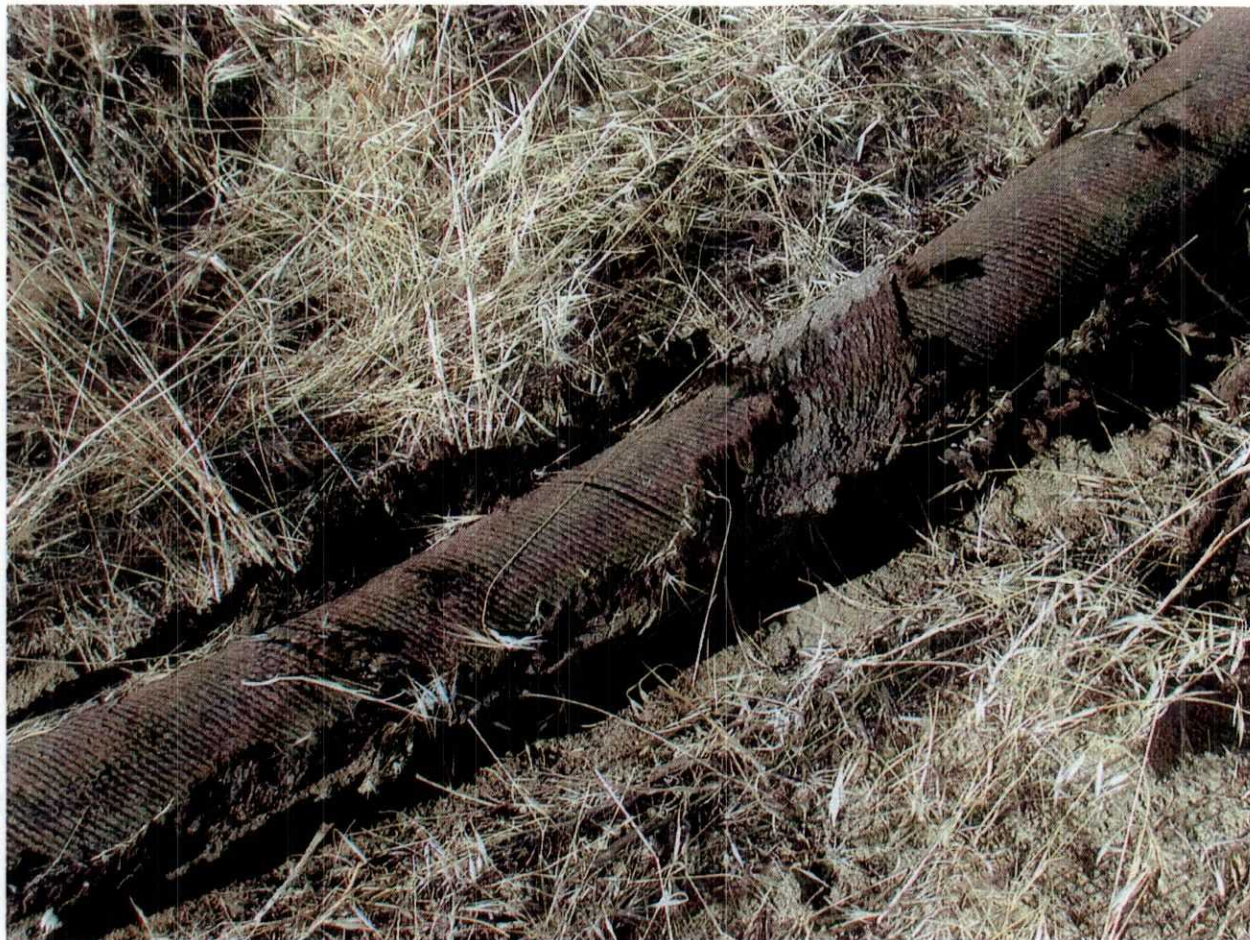
Near the 100-N and 200 East Areas, and on the north shore of the Columbia River, portions of the telecommunications cable has been exposed at the surface and subjected to extreme weather conditions. At these locations, the asphalt rope/twine insulation appears in a variety of conditions, depending upon the environmental extremes. Figure B-4 at the Columbia River north shore shows the asphalt coating eroded and weathered off the top of the cable, exposing the underlying rope/twine wrap. The bottom of the cable, which is in contact with the soil, is protected from weathering and is less eroded. Figure B-5 shows exposed cable in its least eroded condition, with a paper wrapping that was applied to the asphalt during factory manufacture of the cable, probably to label the cable with the manufacturer's name and specifications.

Figure B-4. Telecommunications Cable with Eroded Asphalt Coating and Exposed Underlying Twine/Rope Wrap.

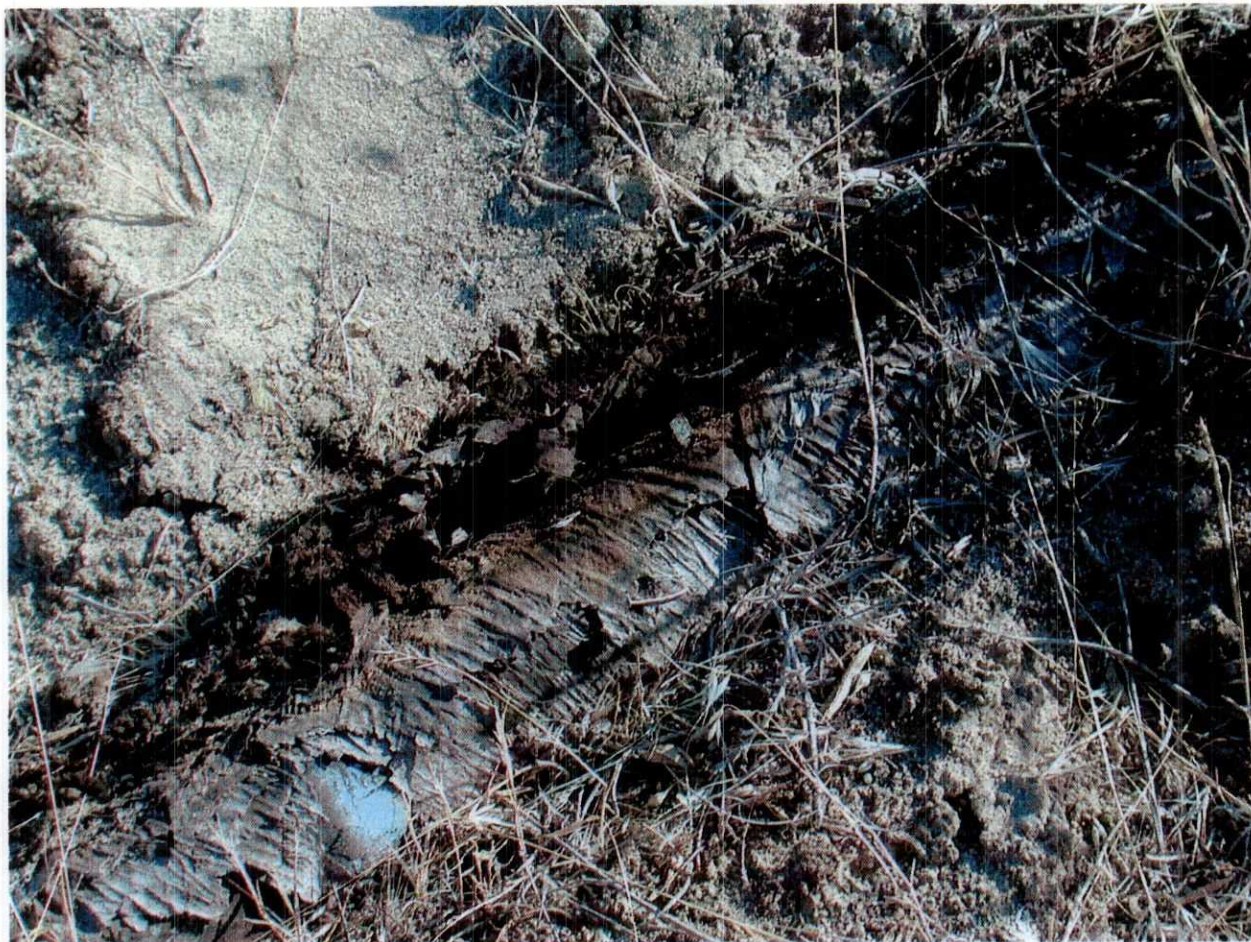
**Figure B-5. Telecommunications Cable in its Least-Eroded Condition,
with Paper Wrapping.**

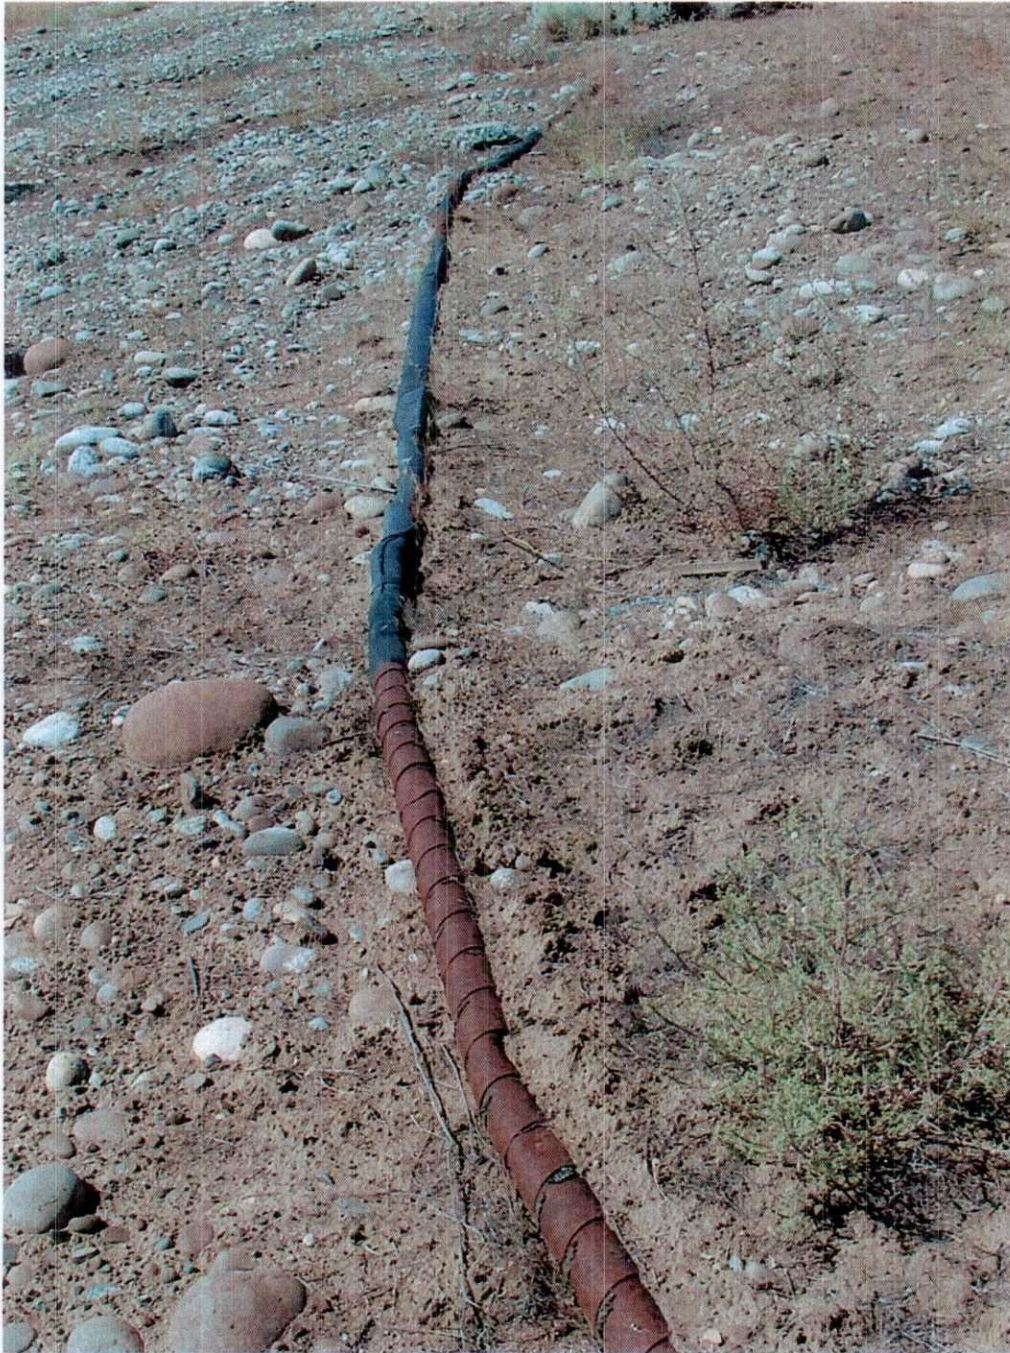
A metal banding is spirally wrapped around the lead sheath at several locations where the cable is exposed. This metal banding was likely used to protect the lead sheath. Figure B-6 shows this metal banding on the exposed cable at the west end of the 100-N Area. The asphalt-coated twine has been eroded or physically removed from the cable. The cable is also exposed at the surface, approximately 32 km (2 mi) southwest of the 200 East Area, on the north side of Route 4. The

abrasive effect of blowing sand has removed the asphalt-coated twine and exposed the metal wrap. However, the asphalt coating is intact underneath the cable where it is in contact with the soil, but is easily friable and removable from the metal banding.

Figure B-6. Telecommunications Cable with Metal Banding.

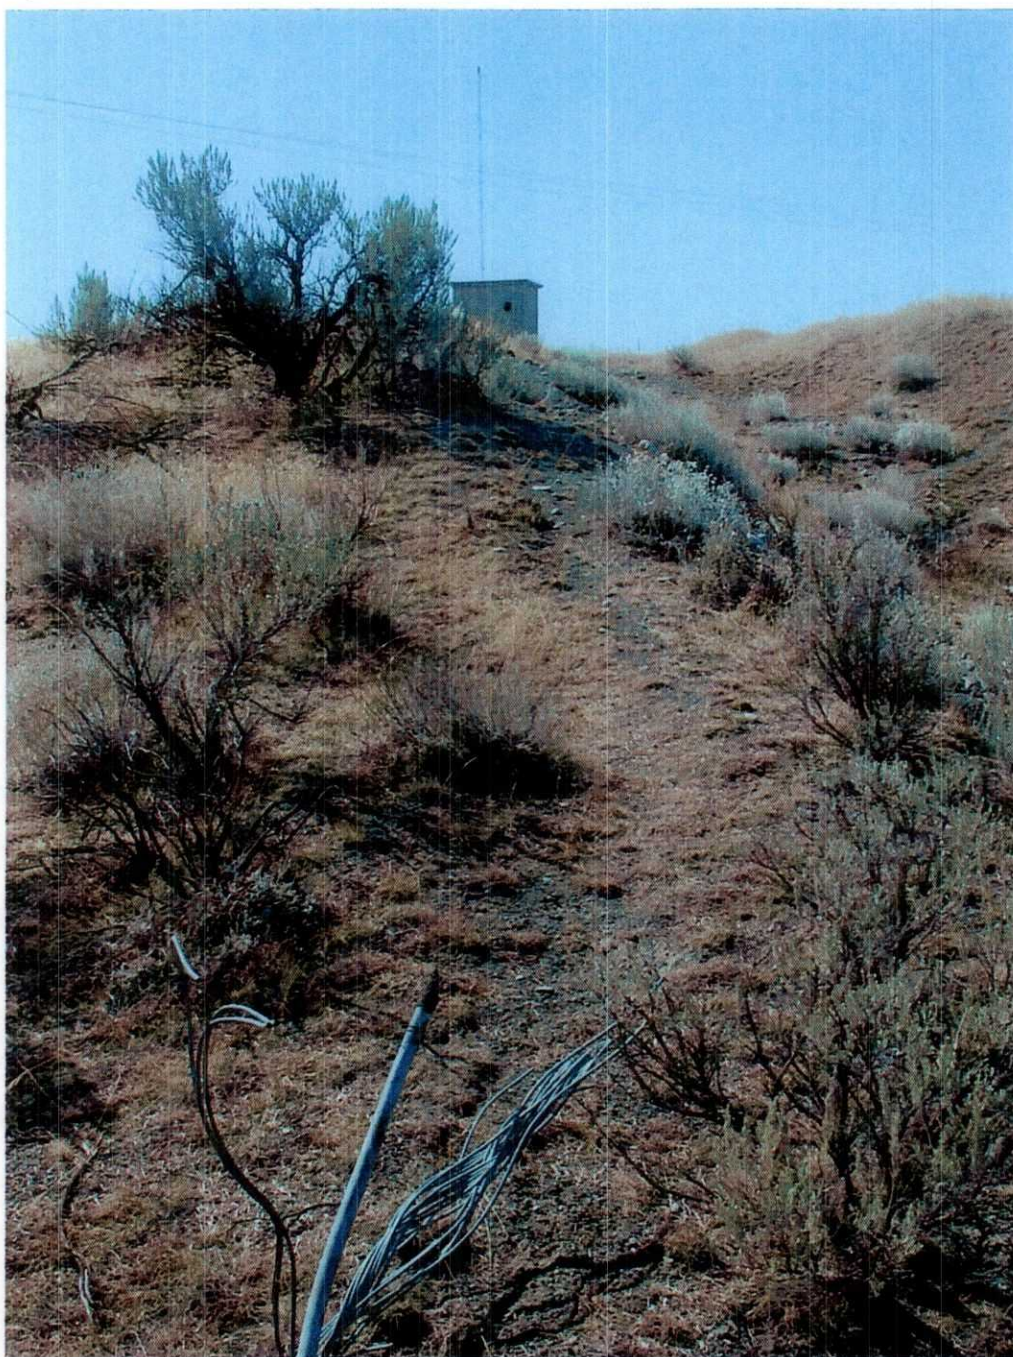
Small concrete block buildings that appear to have been used to support the telecommunication system are located on the north and south shores of the Columbia River, where the telecommunications cables cross under the river. Figure B-7 shows the building on the south shore above the river at the 100-D Area, and Figure B-8 shows the building located on the north shore above the river. The cables are buried as they approach these buildings and cannot be readily observed; therefore, it is unknown whether the cables enter the buildings.

Figure B-7. Concrete Block Building on Columbia River South Shore.

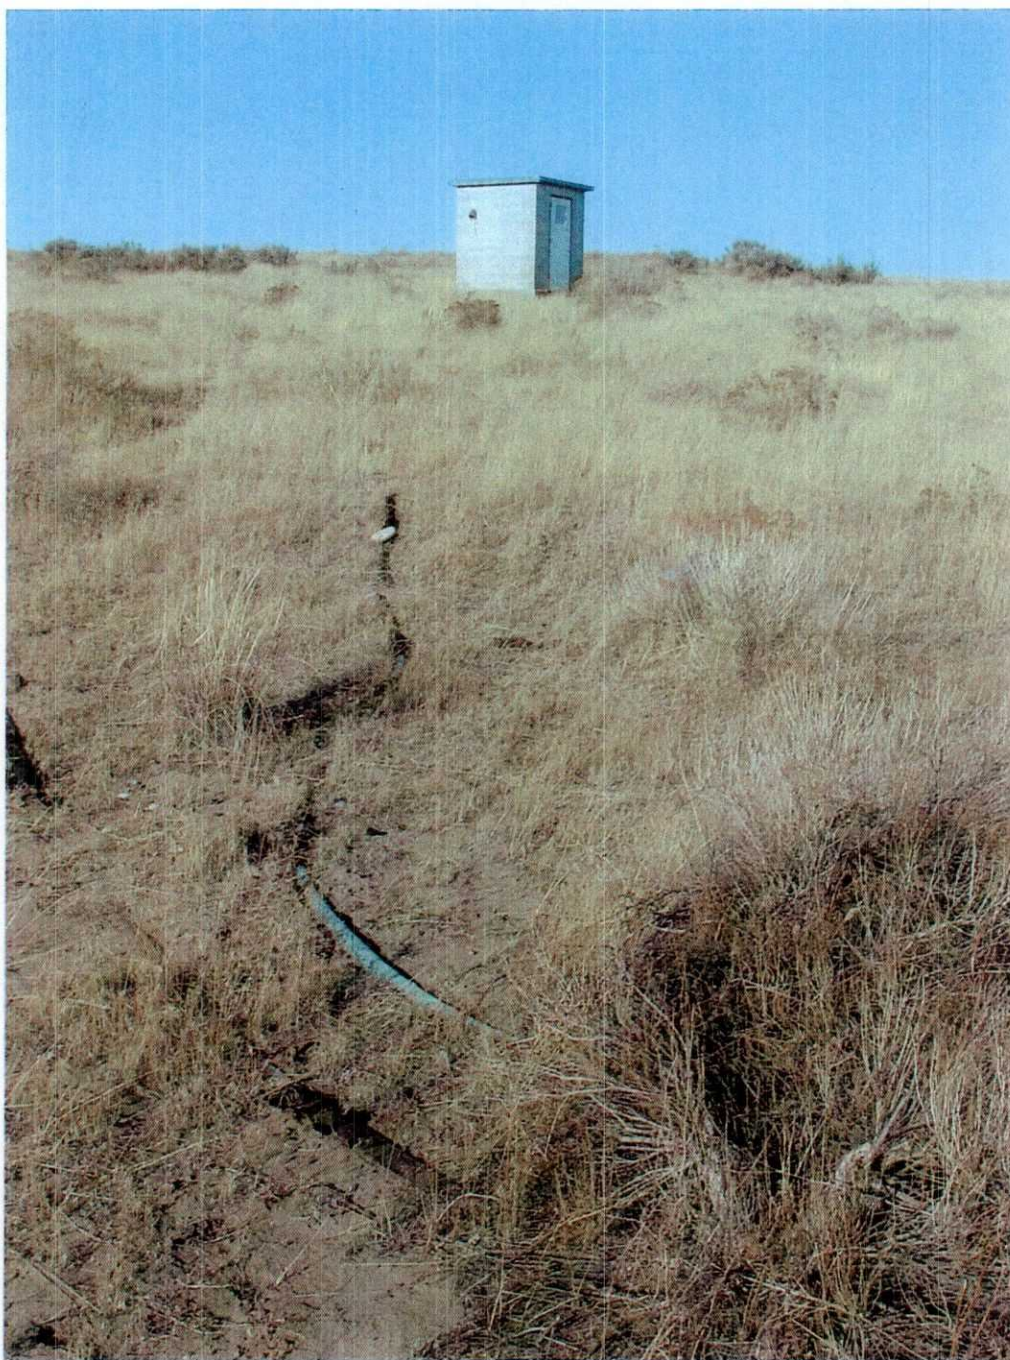
Figure B-8. Concrete Block Building on Columbia River North Shore.
